**GOVERNMENT OF INDIA
MINISTRY OF CIVIL AVIATION
AIRCRAFT ACCIDENT INVESTIGATION BUREAU**

**FINAL INVESTIGATION REPORT ON ACCIDENT TO
DHILLON AVIATION PVT. LTD.
BELL 206 B3 HELICOPTER VT- DDA ON 26-04-2017 AT
CHINTAGUFA HELIPAD, CHHATTISGARH.**

**Final Investigation Report on accident to M/s Dhillon Aviation Pvt. Ltd.
Bell 206 B3 Helicopter VT- DDA on 26-04-2017 at
Chintagufa Helipad, Near Sukma, Chhattisgarh.**

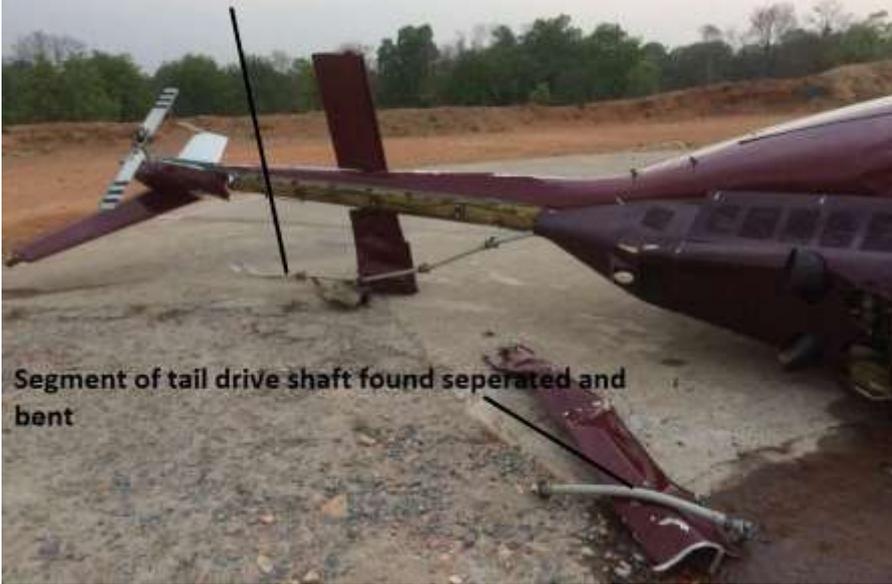
The main rotor drive shaft was found broken due to sudden stoppage of main rotor blades impacting with ground. A segment of tail rotor drive shaft was found bent & detached from the tail gear box adapter input and tail boom structure due to sudden stoppage of main rotor blades after impact.

Tail Drive Shaft found broken and seperated from the tail boom
